GPS Avenger reactivation after lay-up July 2017  
Status per 12 July 2017

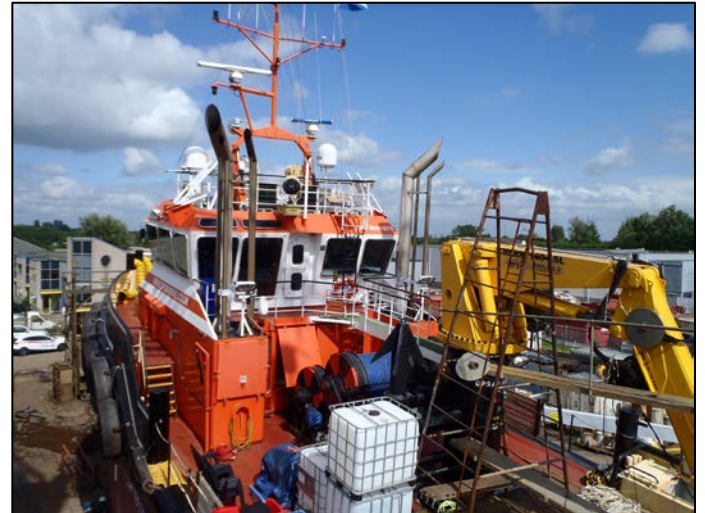
View on stern after fitting Props, and rudders 12-7-2017

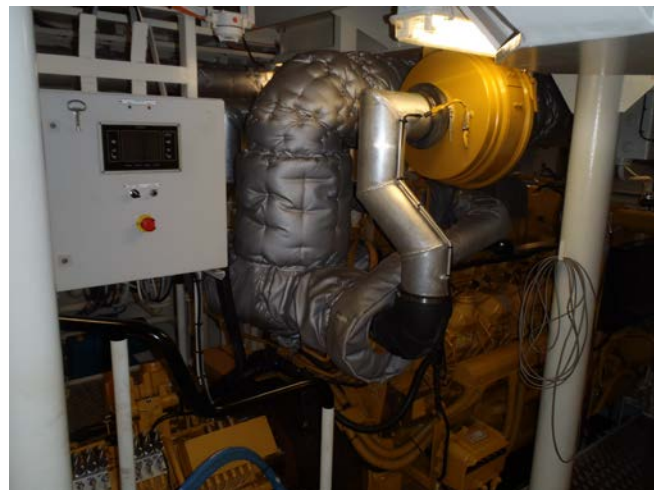
SB Main Engine

- All engines are serviced by the makers Caterpillar, running hours limited < 10.000 and small defects repaired.
- Both propeller shafts withdrawn and inspected.

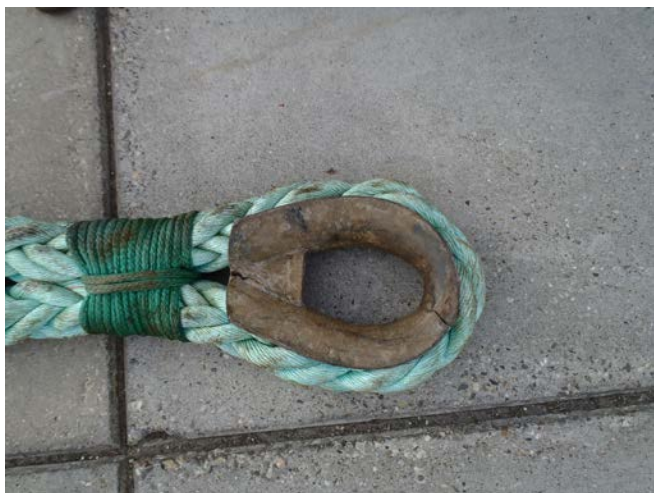
Inspected stretcher

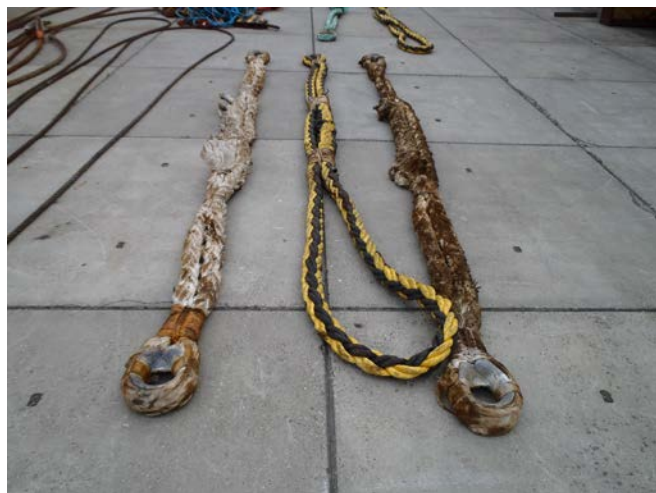
Inspected and rejected due to damaged timble

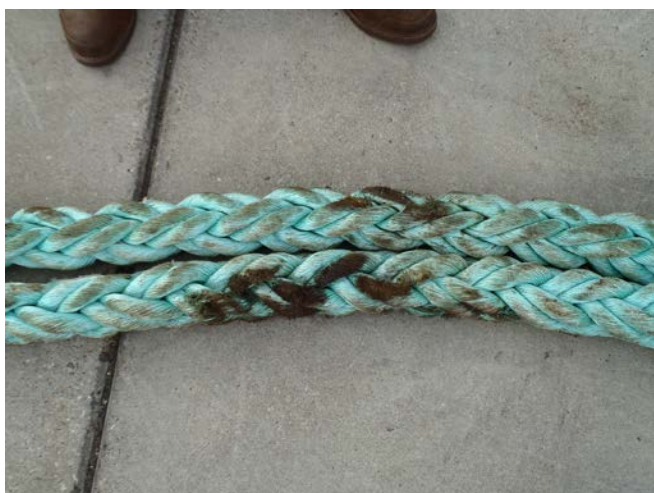
One accepted and two rejected stretchers.
